Manhole Inspection Summary

Manhole # S43I__008MH

Insp Date: **4/30/08 10:23 AM**

Location Address: **1618 s bethel st**

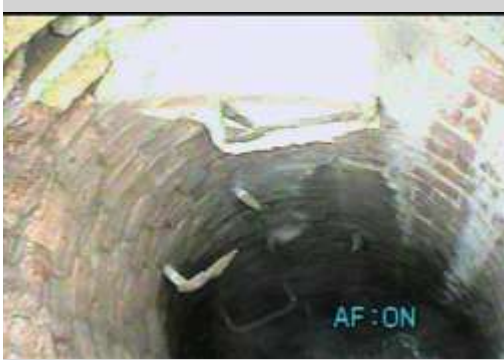
Defect 3

Count: **6** Missing: **2** ☒ **Corroded**

missing and corroded steps

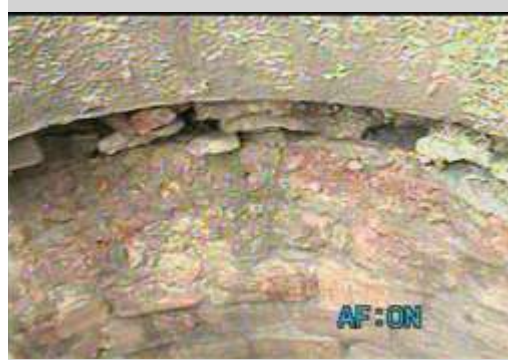
Defect 2

Condition: ☐ Sound ☐ Cracked ☐ Root Intrusion ☒ **Loose Brick** ☒ **Deteriorated**

chimney deteriorated & loose bricks

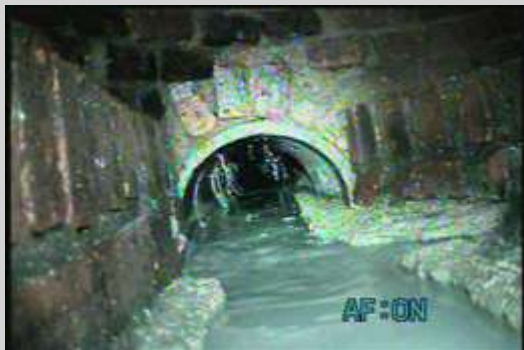
12 O'Clock Outflow

Deposits: ☐ None ☐ Mud ☐ Sludge ☒ **Debris** ☐ Grease

Silt Depth: **2** (in.) Deposits Extent: **Medium**

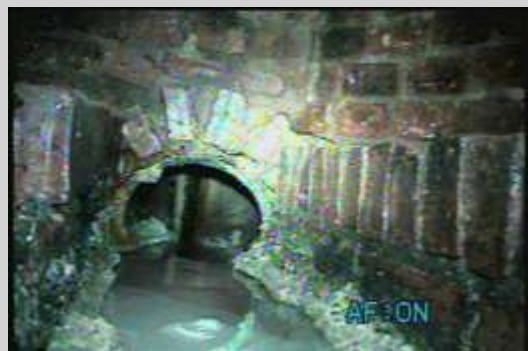
6 O'Clock Inflow

Deposits: ☐ None ☐ Mud ☐ Sludge ☒ **Debris** ☐ Grease

Silt Depth: **1** (in.) Deposits Extent: **Light**
